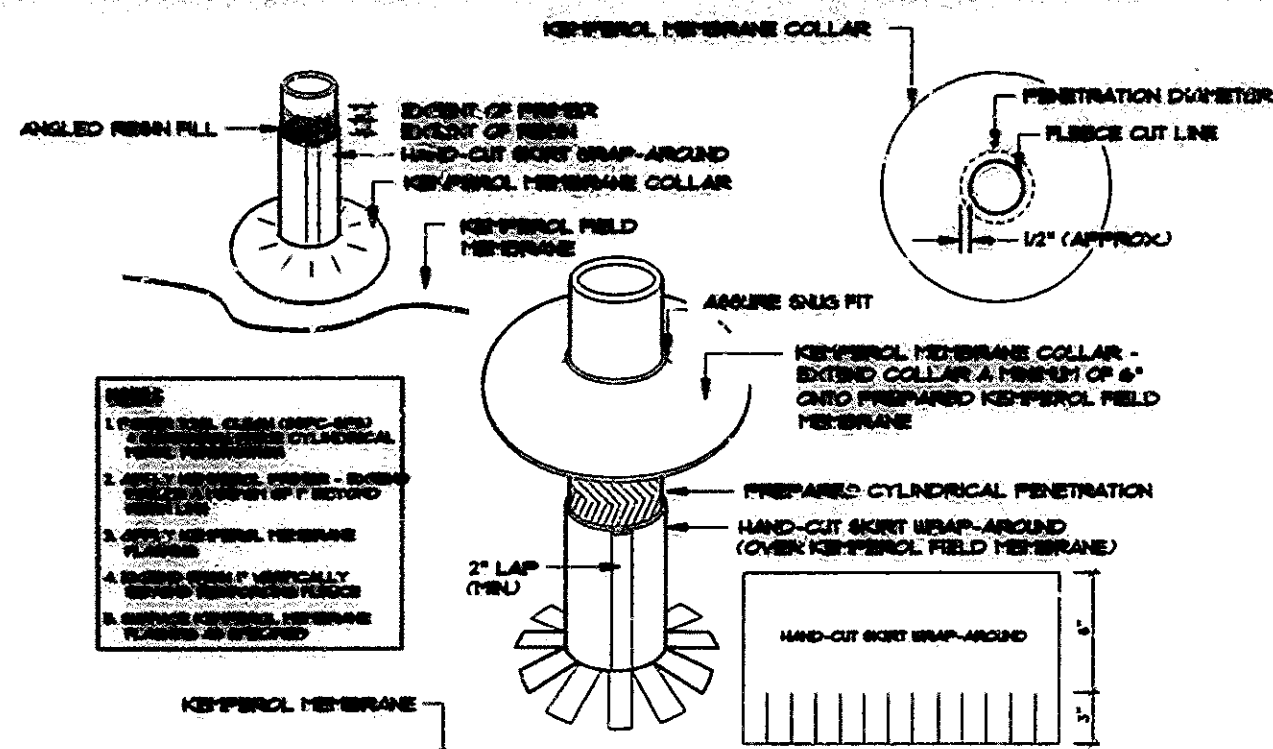
D11 FLASHING AT PFE PENETRATION  
NOT TO SCALE

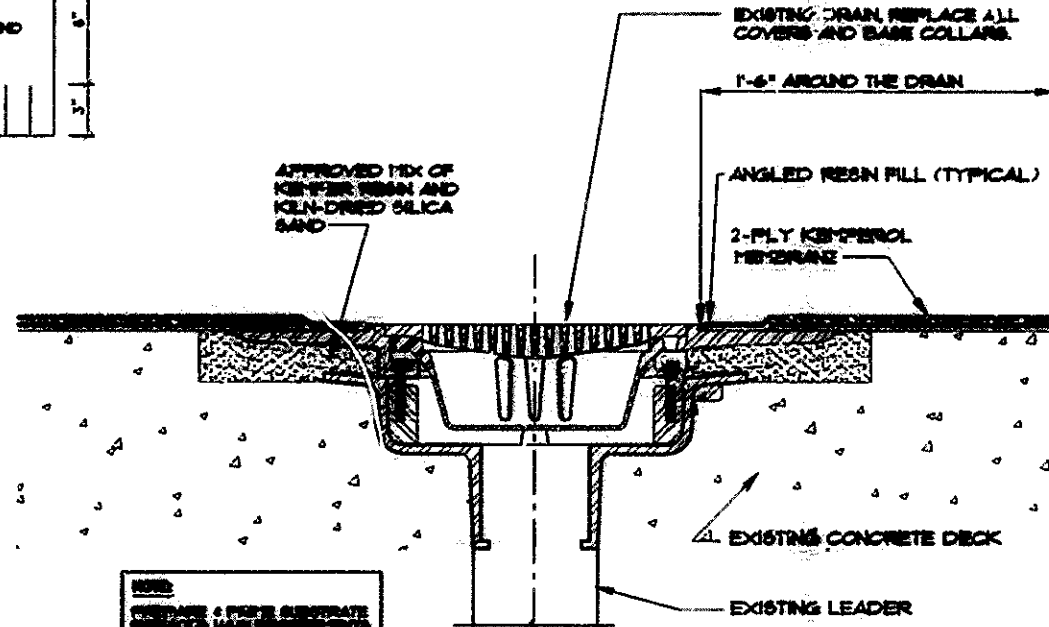
D13 FLASHING - PARK DECK DRAIN (TYPICAL)  
NOT TO SCALE

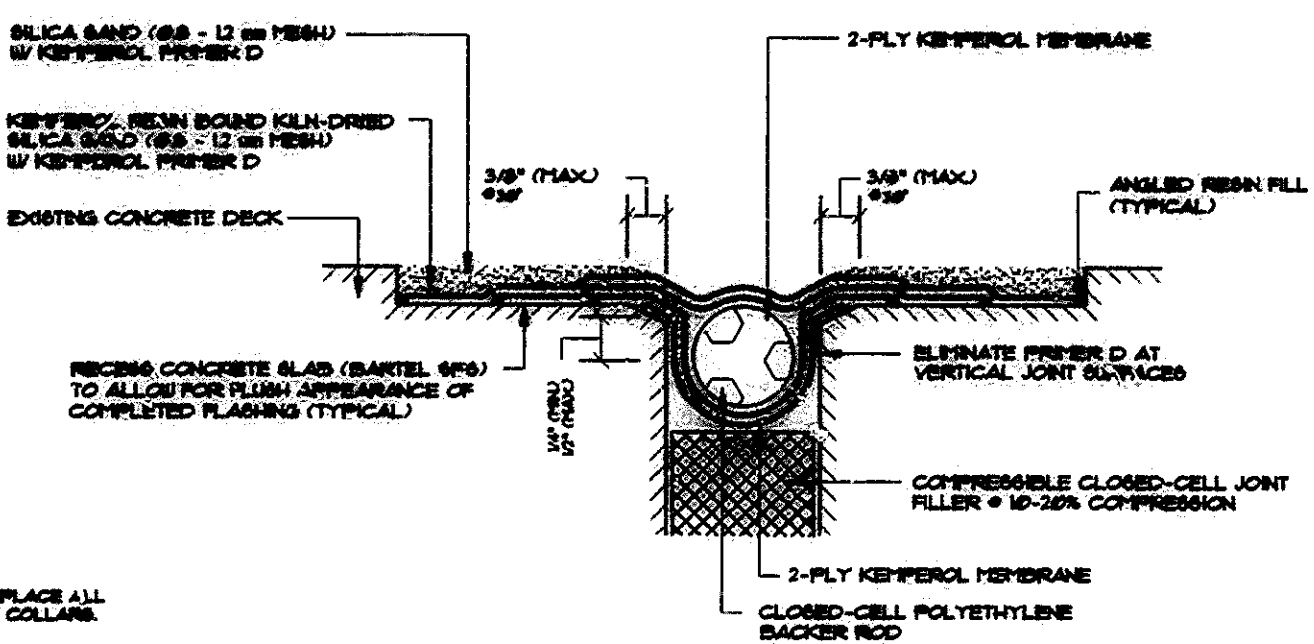
D12 FLASHING - TRAFFIC JOINT (W/ BACKER ROD)  
NOT TO SCALE

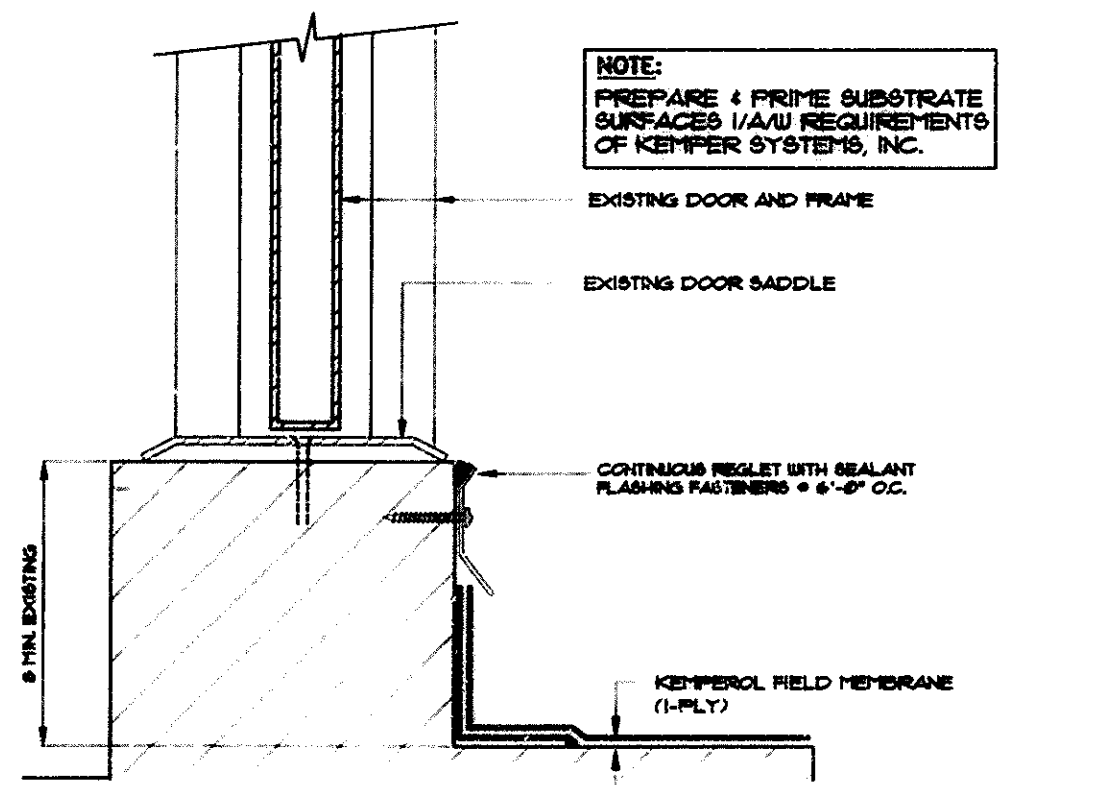
D15 FLASHING - DOOR SILL (TYPICAL)  
NOT TO SCALE
